Karth Lake Management Action Plan

Karth Lake Field Reconnaissance Supplement

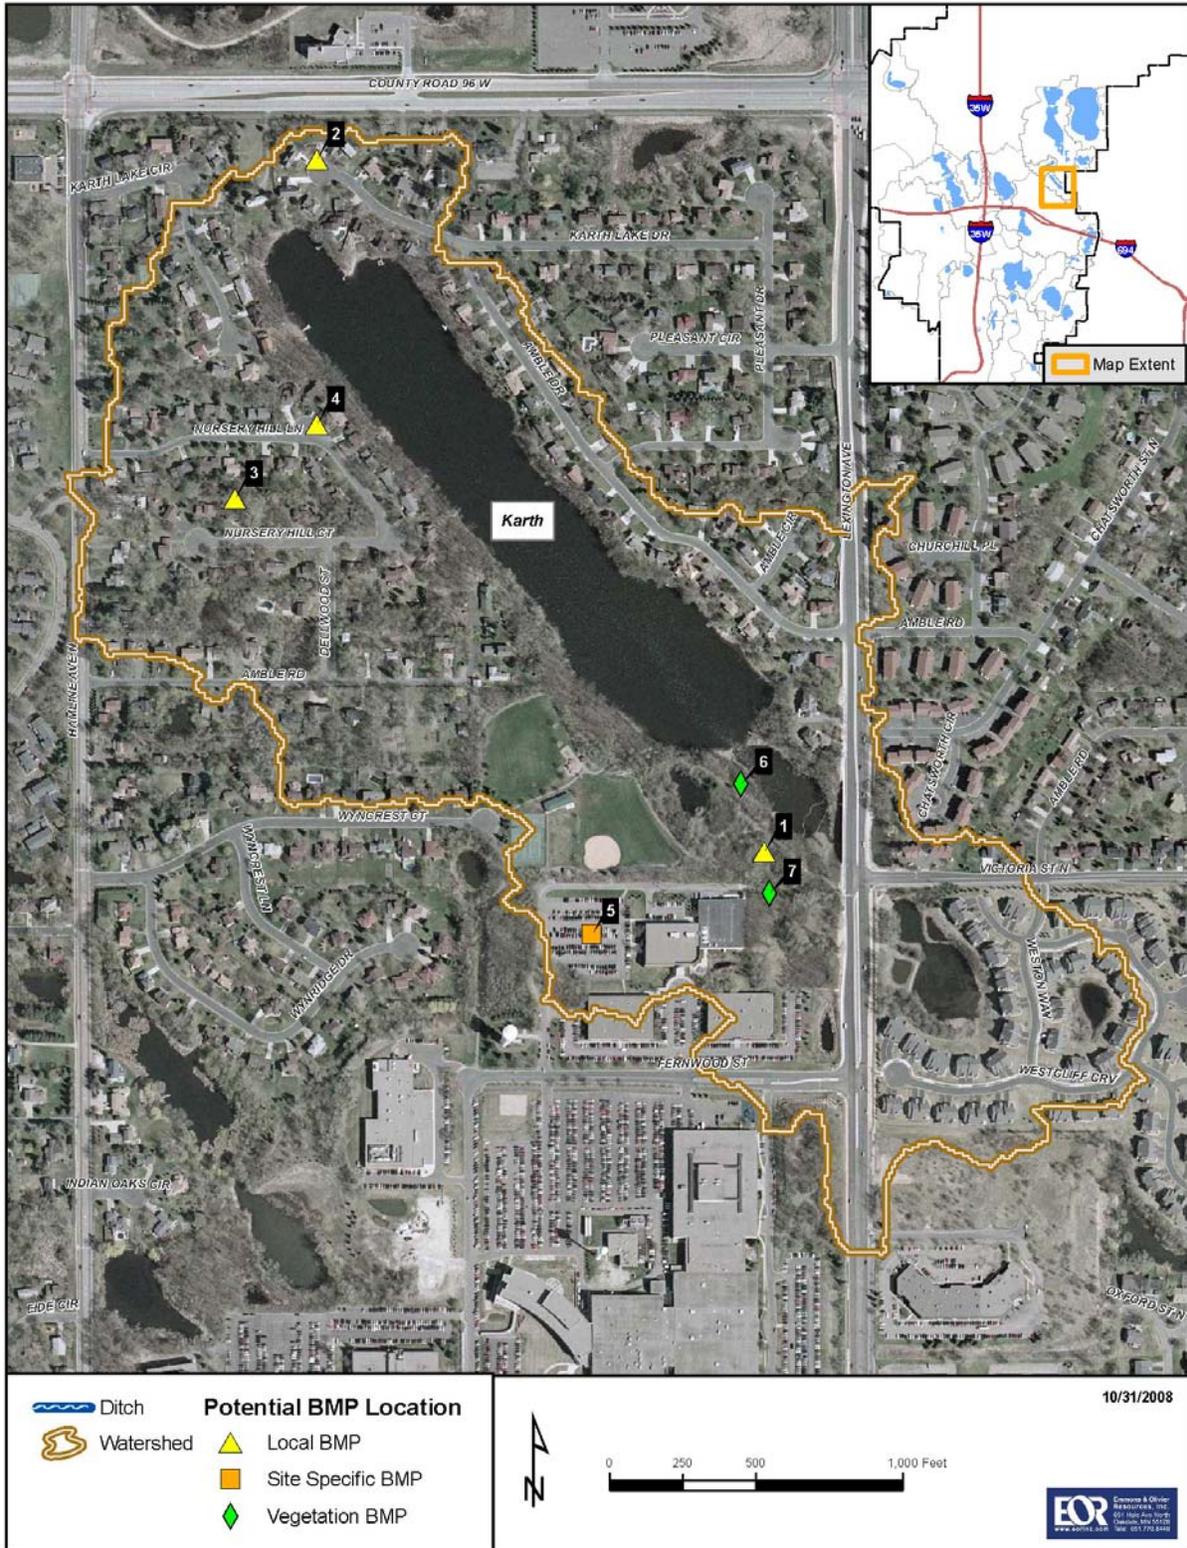
Figure 1. Karth Lake and Potential BMP Locations

specific retrofit opportunities. Potential BMP locations identified during this field investigation are identified on Figure 1 and detailed in the *field reconnaissance supplement* at the end of this report. In summary, four BMP retrofit opportunities were identified in this preliminary field reconnaissance. The following are specific actions that could be pursued to reduce external loading.

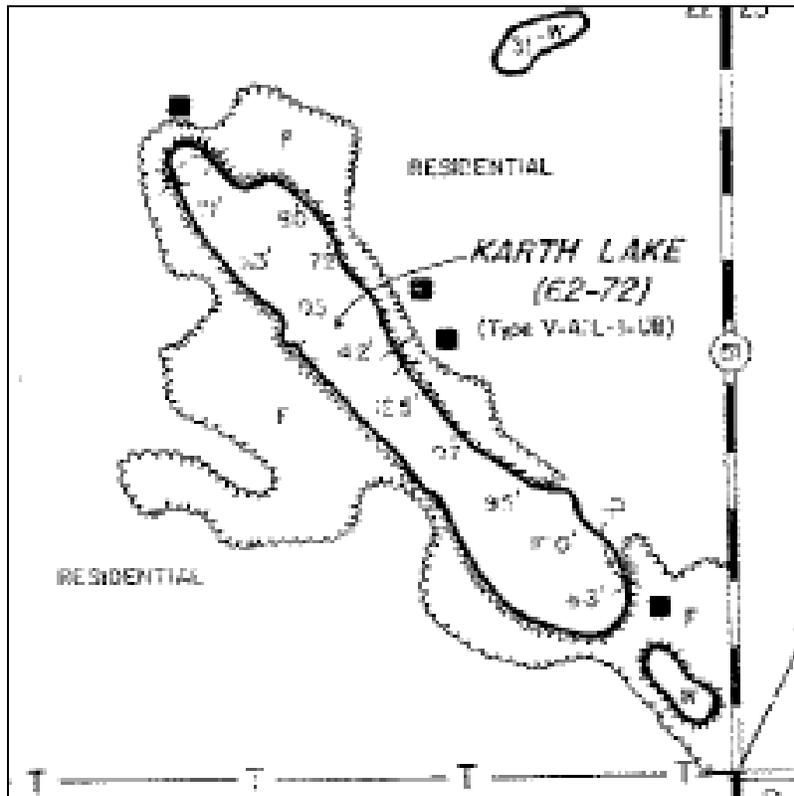
Figure 2. Karth Lake Bathymetry. Map from DNR files, unknown date.

Karth Lake (62-0072) is located in the City of Arden Hills, Ramsey County, Minnesota (Figure 1). The surface area of the lake is approximately 20 acres (Figure 2) and the lake has a maximum depth of 14 ft.¹ Based on its low maximum depth, it is considered a shallow lake according to MPCA's definition.

- Updated bathymetric data collection
- TP, chlorophyll, and Secchi depth data: Collect data for one to two additional years, with at least five sampling dates per year. Continued support of data collection through the CAMP program will provide sufficient information.

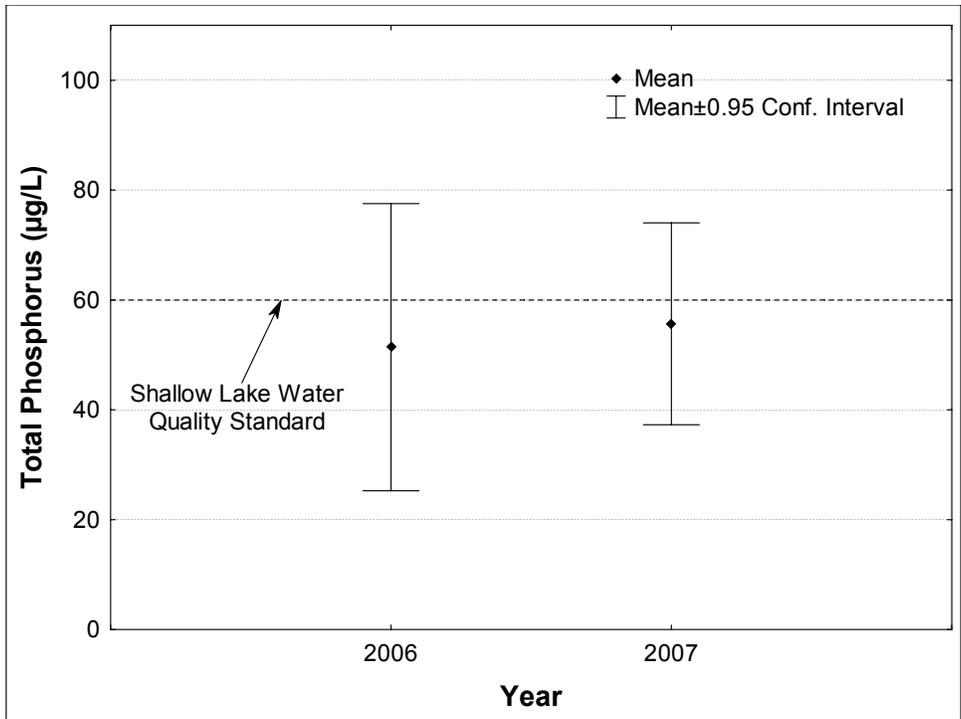
Figure 3. Karth Lake Total Phosphorus

Limited historic data exist on the quality of Karth Lake. The Metropolitan Council's Citizen Assisted Monitoring Program (CAMP) has had the lake as part of its program since 2006. A summary of the CAMP data taken over the last two years (Table 1) shows that Karth Lake is meeting the water quality standards for shallow lakes.

Figures 2 through 4 show the total phosphorus (TP), chlorophyll-*a*, and Secchi depth (clarity) data from Karth Lake.

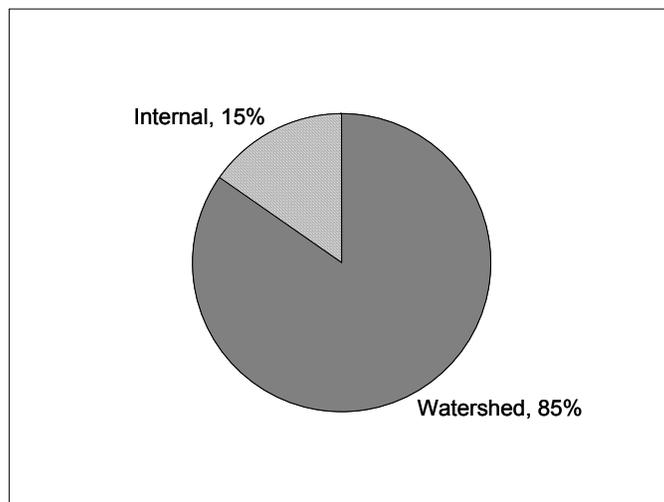
Figure 6. Karth Lake Phosphorus Load Distribution

A watershed model (P8) was used to estimate the watershed phosphorus load to the lake, and an in-lake model (Bathtub) was used to predict the response of the lake to phosphorus loading. The lake model was calibrated to in-lake monitoring data. Water quality modeling indicates that the watershed inputs account for approximately 85% of the nutrient load, with internal loading accounting for the remaining 15% (Figure 6).

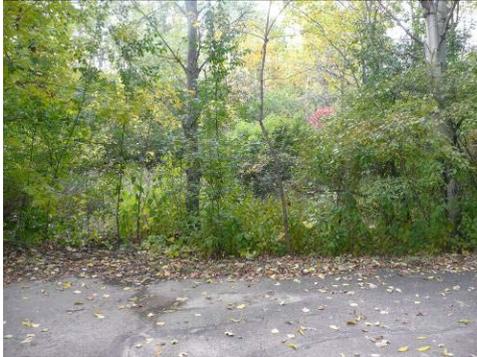
Karth #1

Location: South end of Karth Lake

Description: Low wooded area that could be used to treat the large manufacturing business south of lake. There is room to incorporate a good sized feature, which would be needed for that large amount of impervious draining to this location.

Potential Improvements: Incorporate ponding, infiltration, or wetland treatment depending on soils and water table.

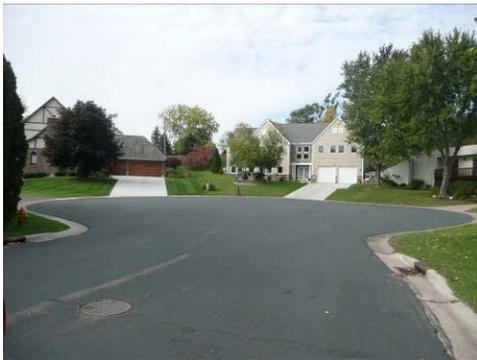
Karth #2

Location: Cul-de-sac at the end of Karth Lake Drive

Description: Catch basins drain directly to lake

Potential Improvements: Incorporate island with treatment in cul-de-sac to treat adjacent impervious.

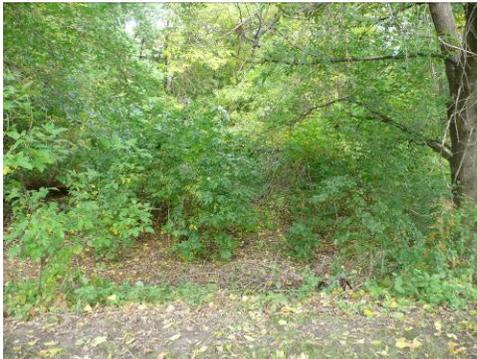
Karth #3

Location: North of Nursery Hill Court and west of Dellwood Street

Description: Low wooded wetland area

Potential Improvements: Incorporate treatment for adjacent roads (would need to assess current quality and function of the wetland)

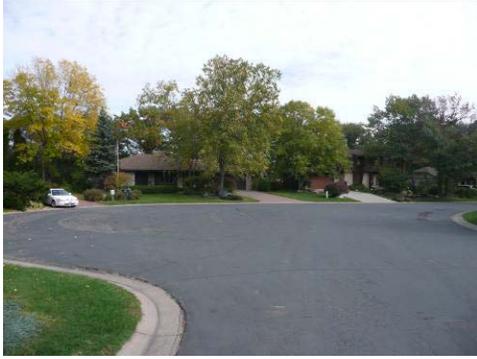
Karth #4

Location: Cul-de-sac on Nursery Hill Lane

Description: A lot of unnecessary impervious, typical of several neighborhood streets around Karth Lake.

Potential Improvements: Incorporate islands with treatment in cul-de-sacs and reduce street widths. Reclaimed green space could also be used for raingardens.

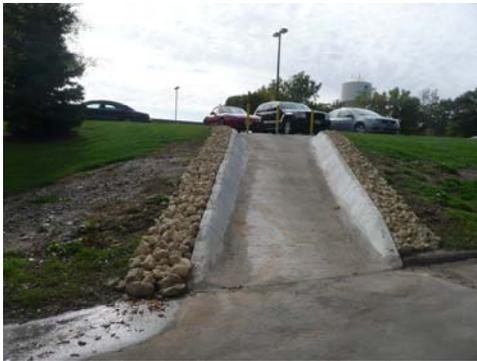
Karth #5

Location: Parking lot serving manufacturing business south of Karth Lake

Description: The flume for storm water runoff from the large parking area currently discharges offsite untreated.

Potential Improvements: Incorporate stormwater treatment retrofits onsite during pavement maintenance.

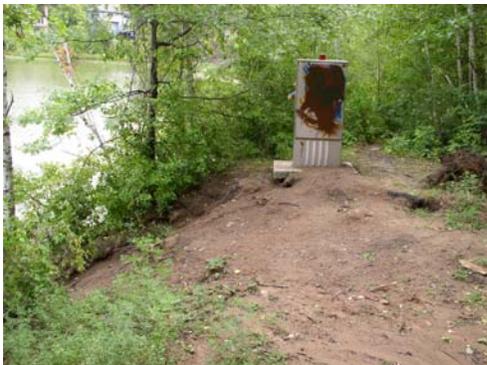
Karth #6

- Curly-leaf pondweed, a nuisance macrophyte, is present in the lake. Curly-leaf may contribute to internal loading of phosphorus.
- Soil erosion has been observed at the site of the outlet pump on the south side of the lake.
- There is an access/parking street between the commercial/industrial area and the lake that slopes steeply to the east and discharges water at a high velocity into a channel draining to the lake.

Location: South end of Karth Lake

Description: Outlet pump and associated erosion.

Potential Improvements: Incorporate erosion control measures to prevent sediments from entering the lake.
