Feasibility Report for

# 2024 PMP Street & Utility Improvements City of Arden Hills

July 2023

City of Arden Hills  
Arden Hills, Minnesota  
City Project No. PW-24-0100  
BMI Project No. OT1.130168

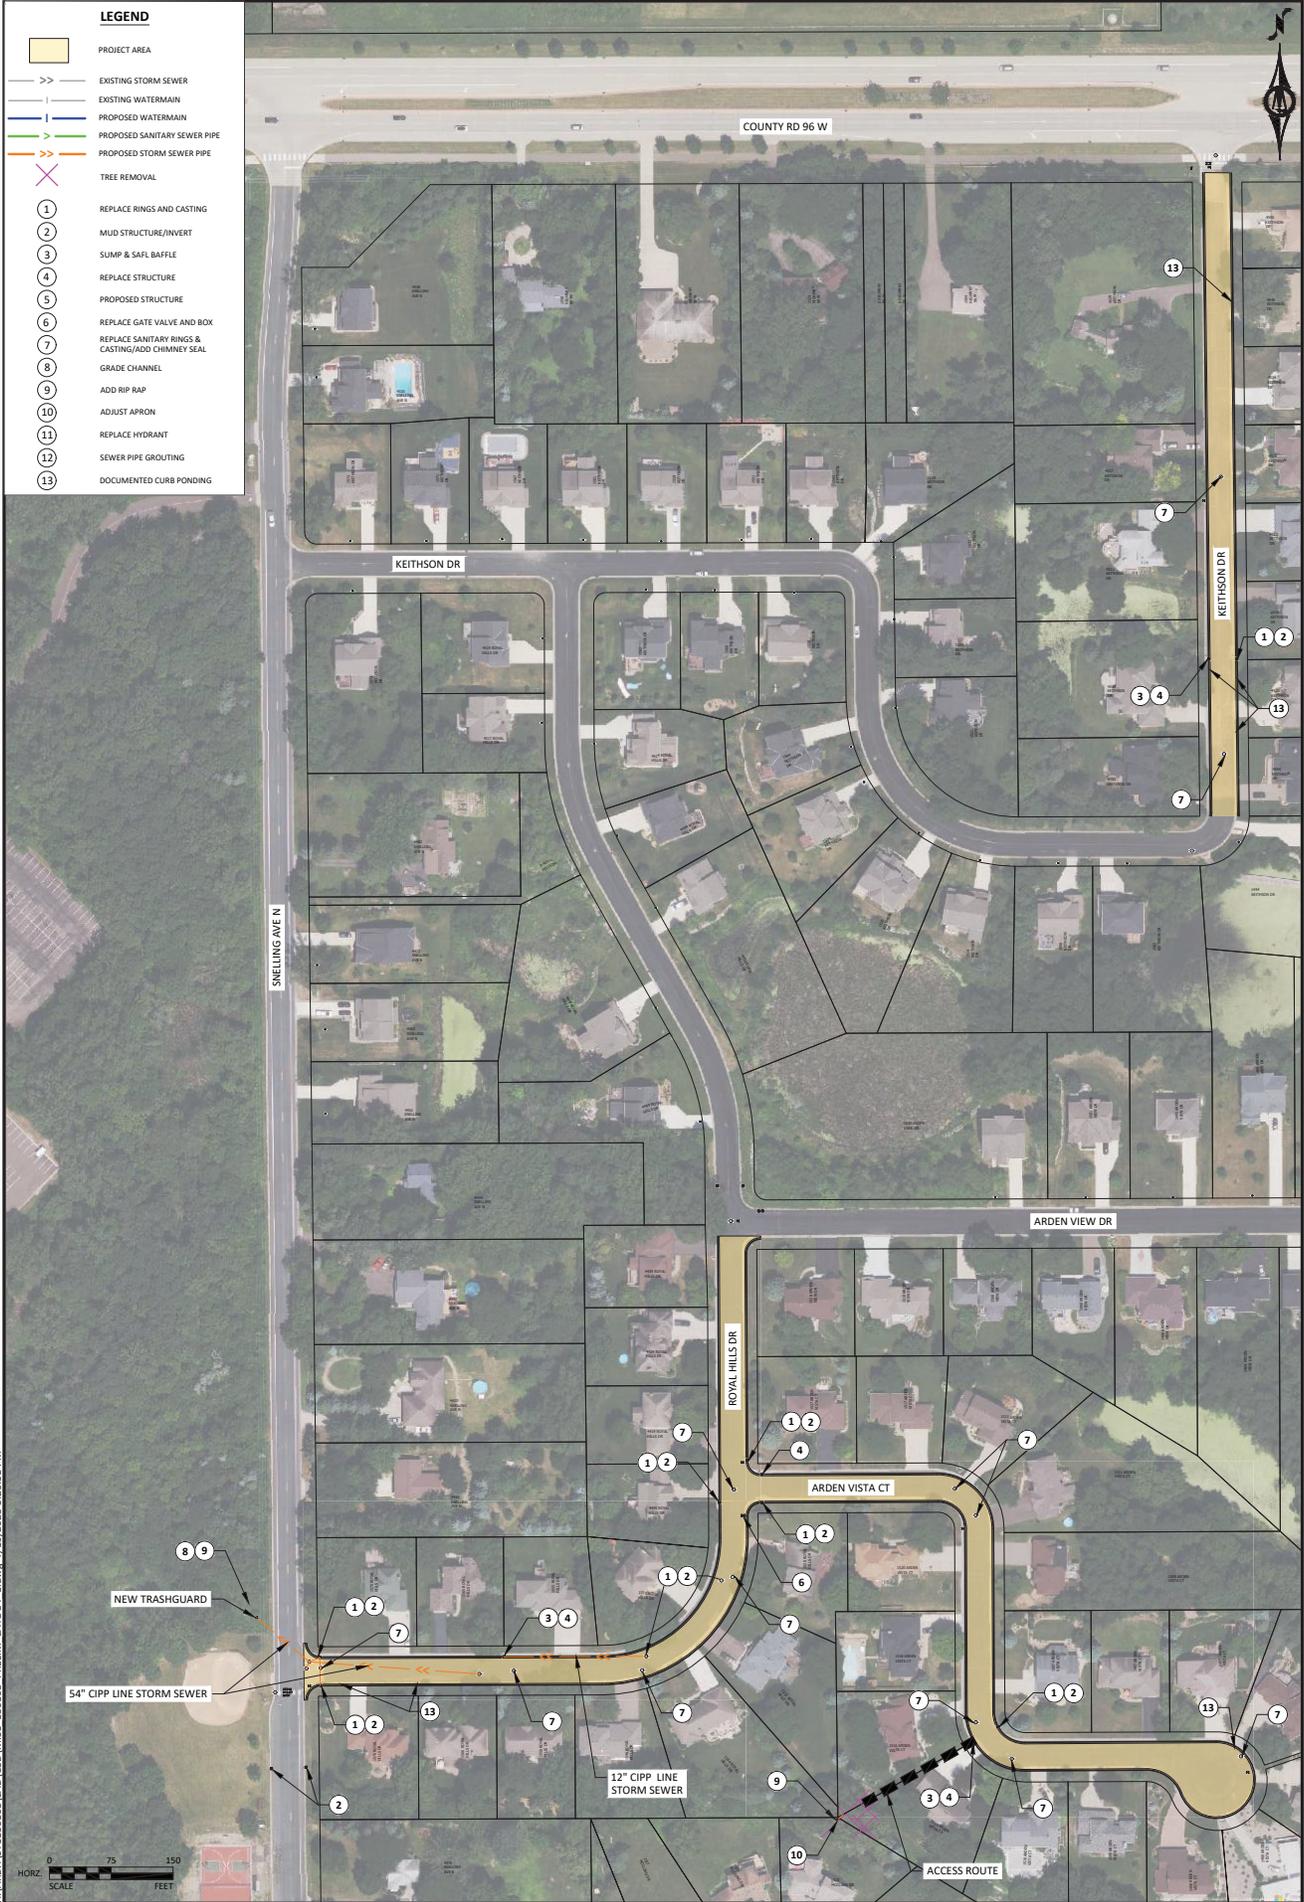
See Figure 1 in Appendix A for the proposed project layout identifying the trails to be rehabilitated and the locations of ADA pedestrian ramp improvements. See Figure 3 in Appendix A for the proposed retaining wall and bituminous curb replacements.

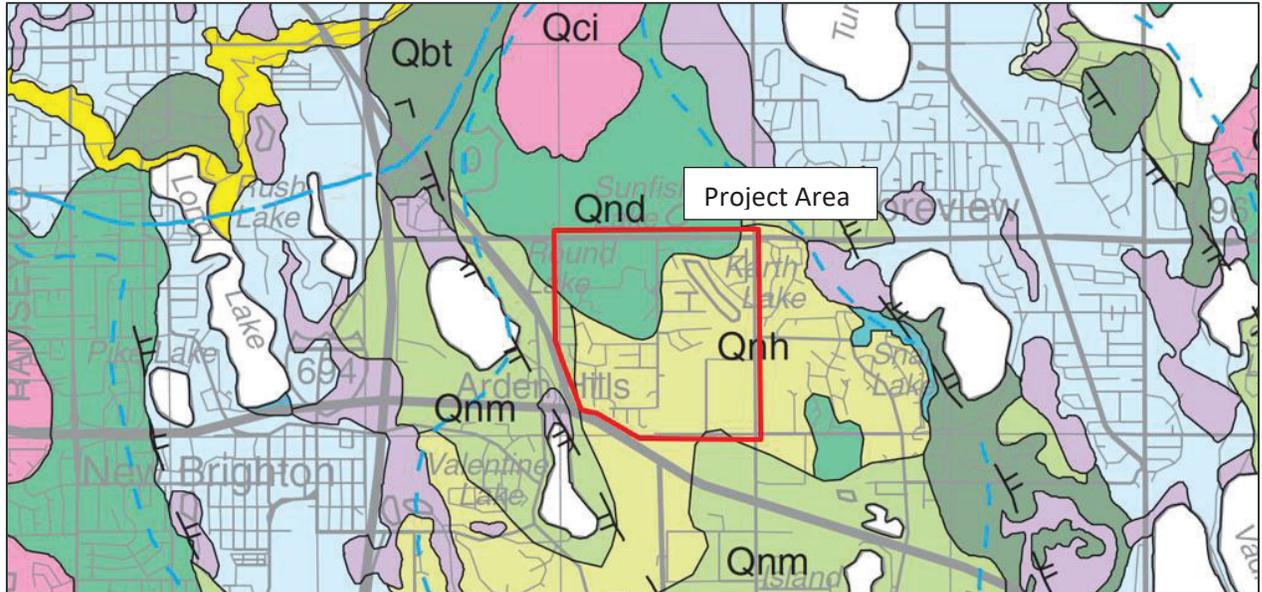
**Figure 1. Project Area Surficial Geology**

A review of the Minnesota Metropolitan Area Geologic Atlas indicates the project area is generally underlain by intermixed loam to sandy-loam textured unsorted sediment associated with the Twin Cities Member (Map Unit "Qnd") and glacial till soils that have deposits that form hummocky, irregular topography (Map Unit "Qnh").

Image extracted from the Metropolitan Area Geologic Atlas, dated 2007.

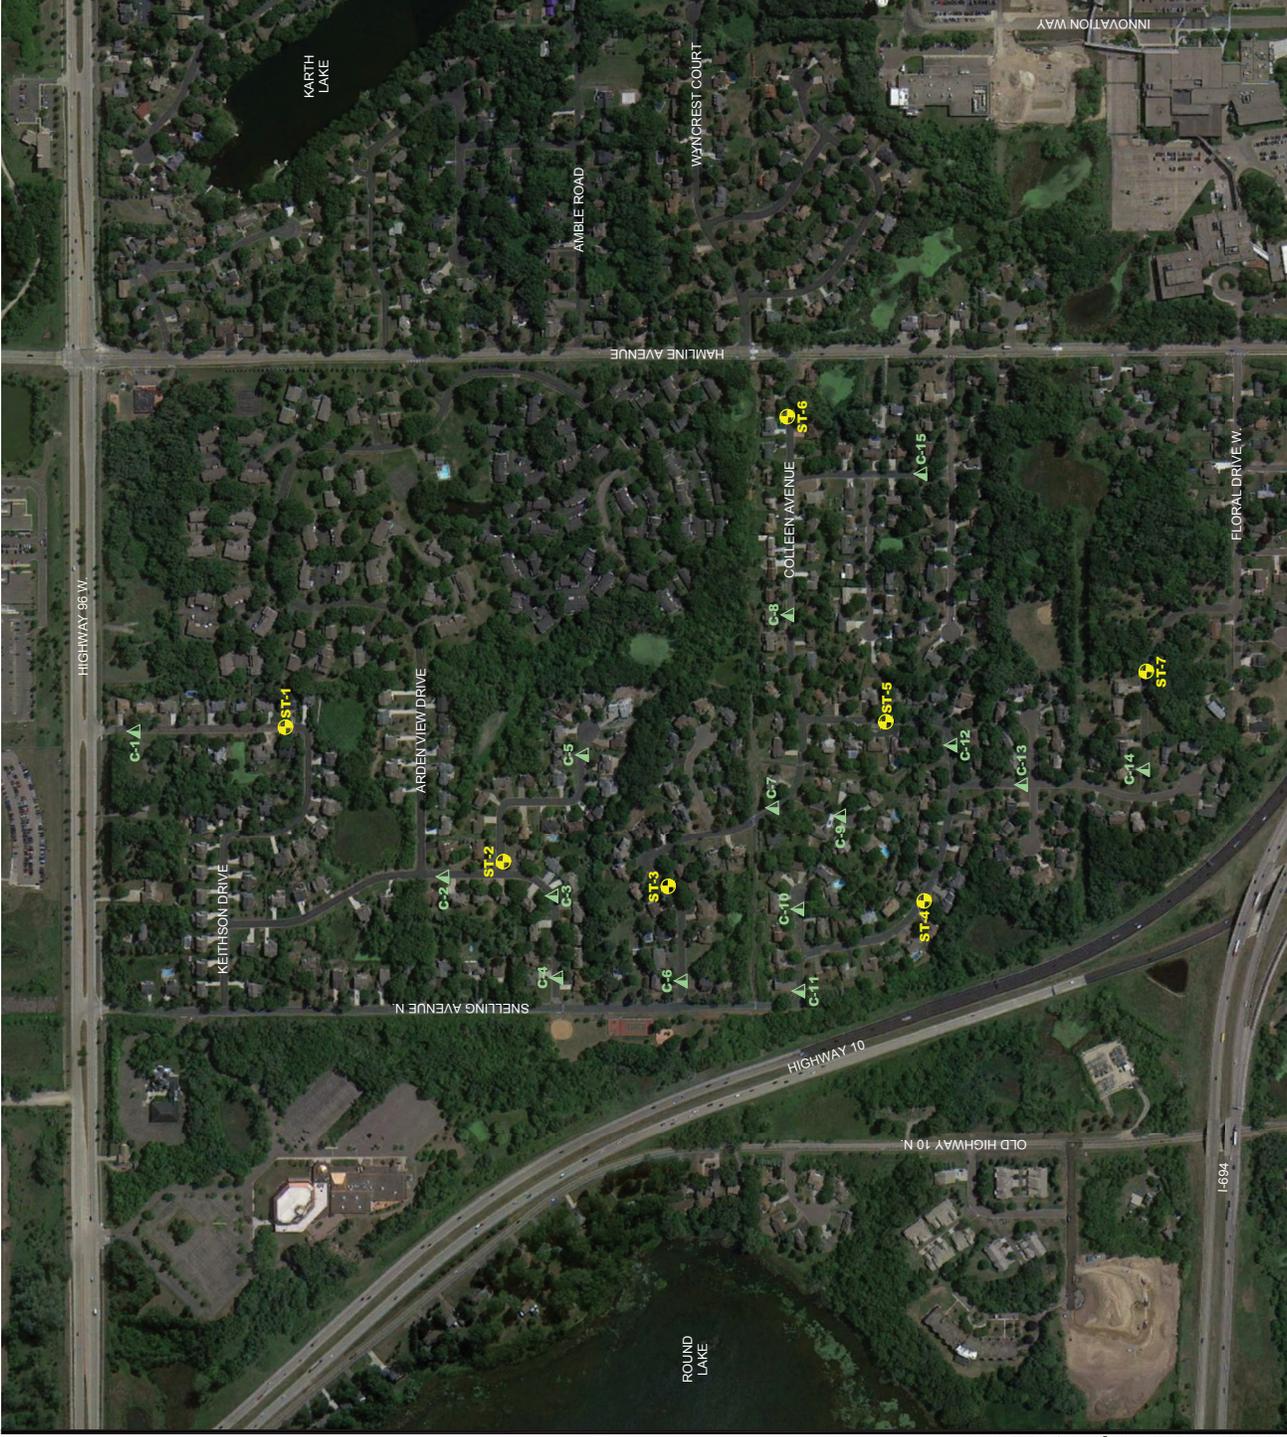
**Soil Boring  
Location Sketch**

**●** DENOTES APPROXIMATE LOCATION OF STANDARD PENETRATION TEST BORING

**▲** DENOTES APPROXIMATE LOCATION OF PAVEMENT CORE

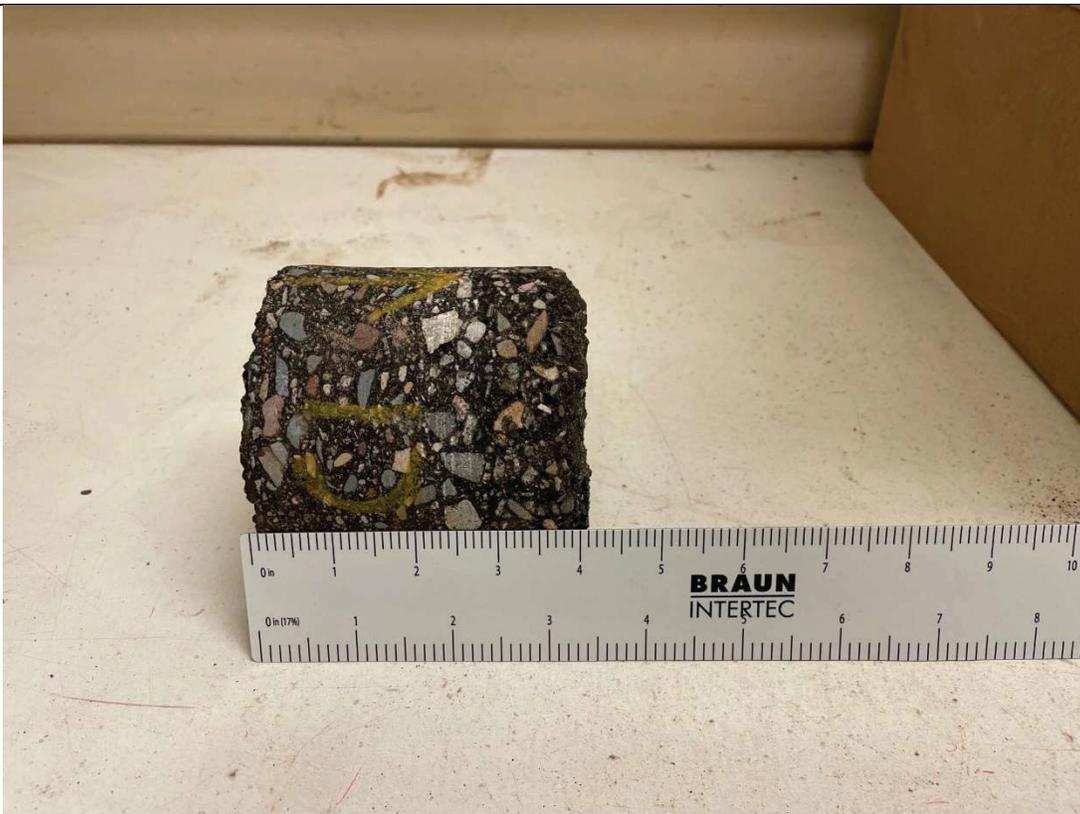
Core #:	C-1			Project: B2204011 <b>BRAUN</b> INTERTEC
Pavement thickness:	4 inches	Agg base thickness:	8 inches	
Location:	Keithson Drive			
Date:	June 2022

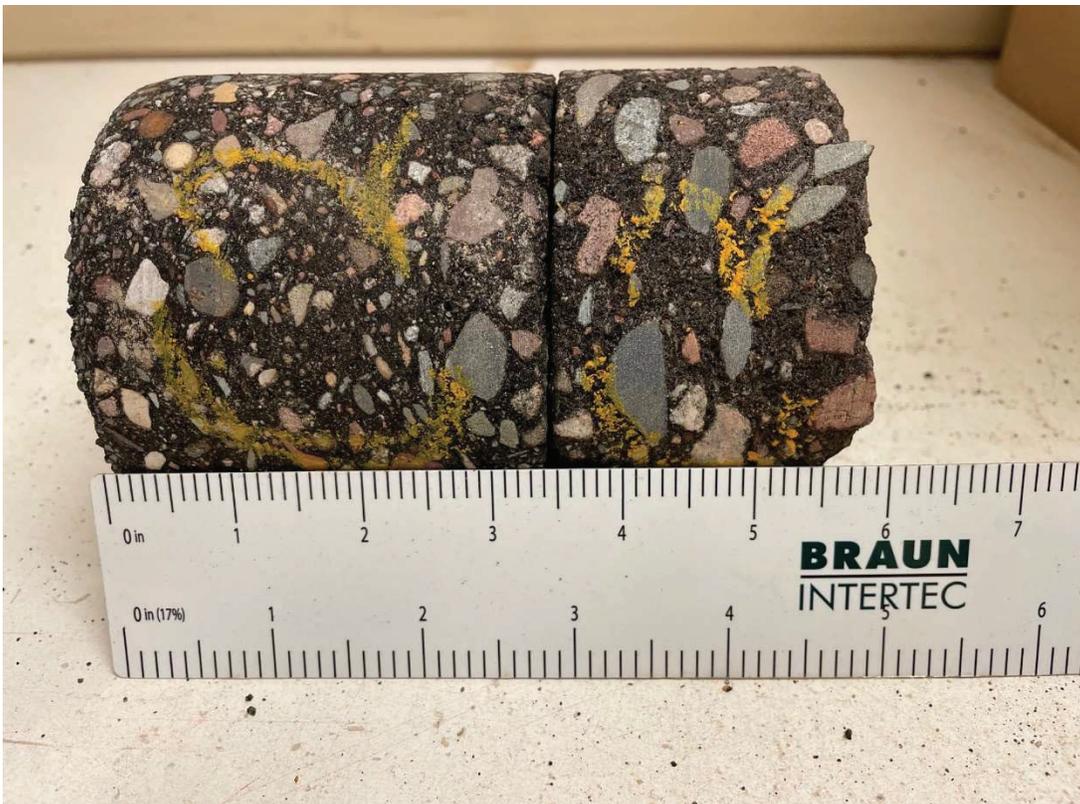
Core #:	C-2			Project: B2204011 <b>BRAUN</b> INTERTEC
Pavement thickness:	5 3/4 inches	Agg base thickness:	5 inches	
Location:	Royal Hills Drive			
Date:	June 2022

Notes: Debonded at 3 1/2 inches

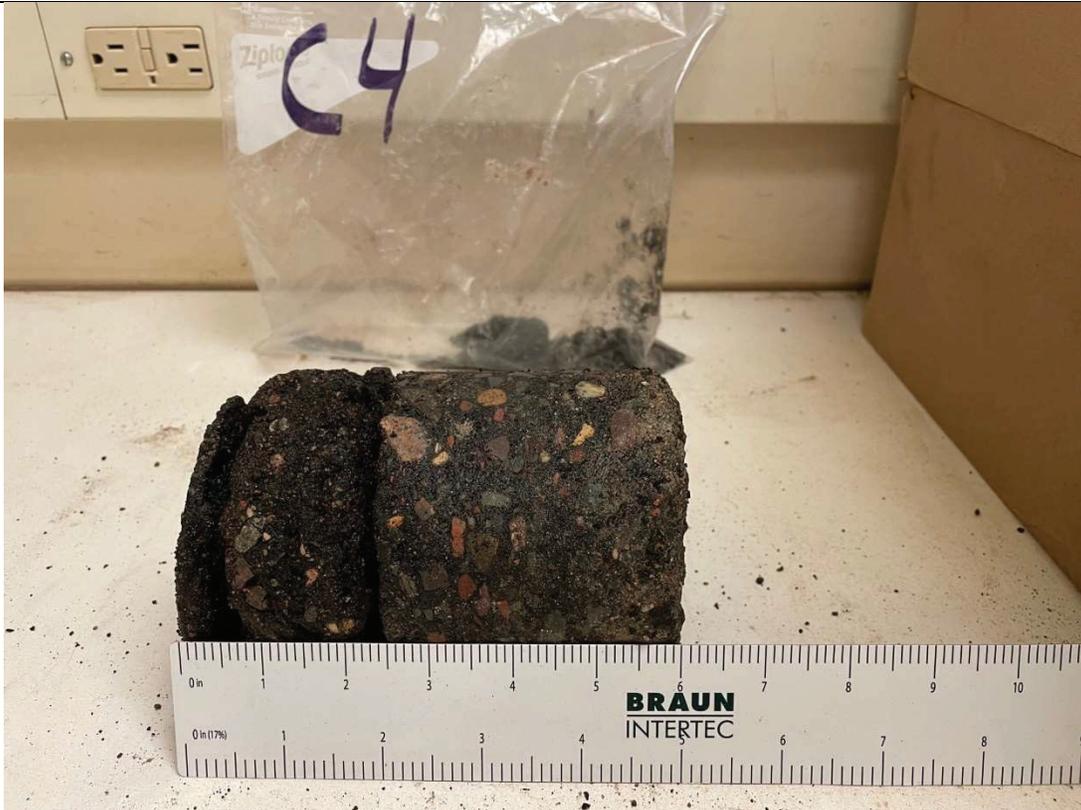
Core #:	C-4			<b>BRAUN</b> <b>INTERTEC</b>
Pavement thickness	6 inches	Agg base thickness:	9 1/2 inches	
Location:	Royal Hills Drive			
Date:	June 2022

Notes: Debonding at chip seal and at 2 1/2 inches. Core appears to have moderate to high stripping.

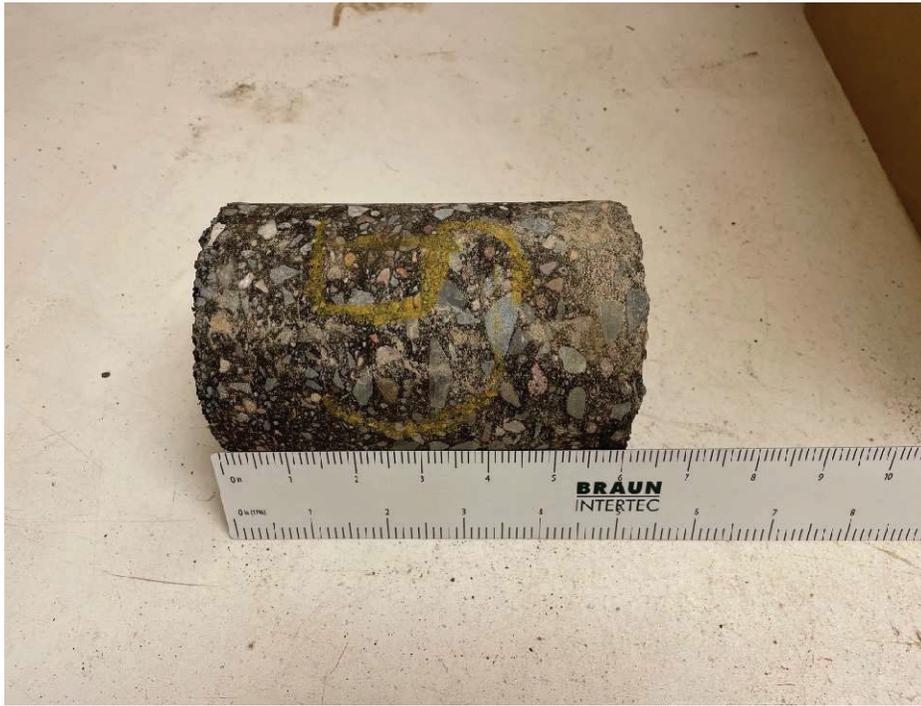
Core #:	C-5			Project: B2204011 <b>BRAUN</b> INTERTEC
Pavement thickness:	6 1/4 inches	Agg base thickness:	5 inches	
Location:	Arden Vista Court			
Date:	June 2022			
Notes:

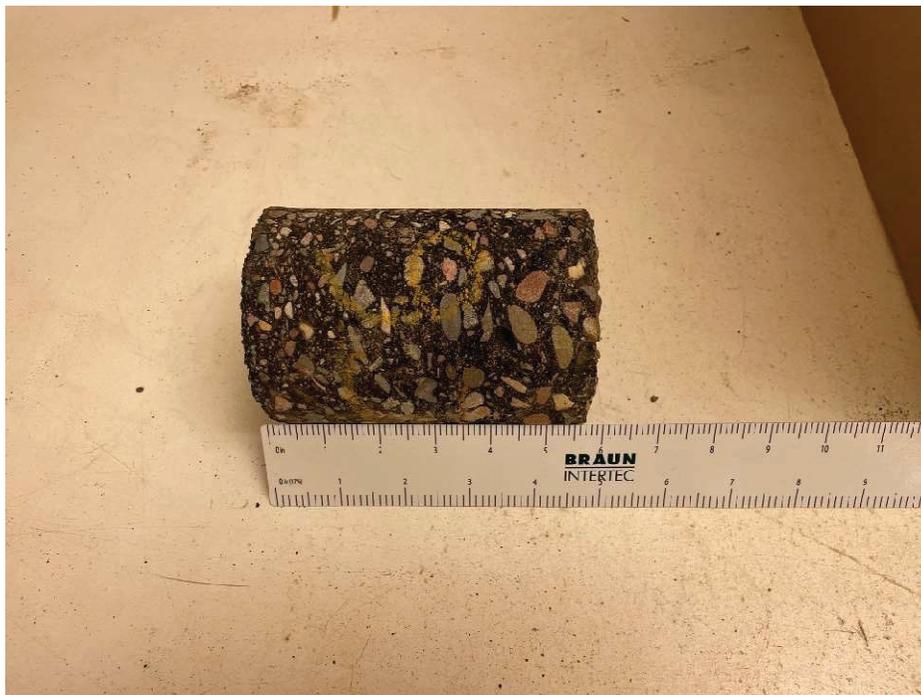
Core #:	C-6			Project: B2204011 <b>BRAUN</b> INTERTEC
Pavement thickness:	6 inches	Agg base thickness:	16 inches	
Location:	McClung Drive			
Date:	June 2022			
Notes:	Slight stripping from 3 1/2 to 6 inches.

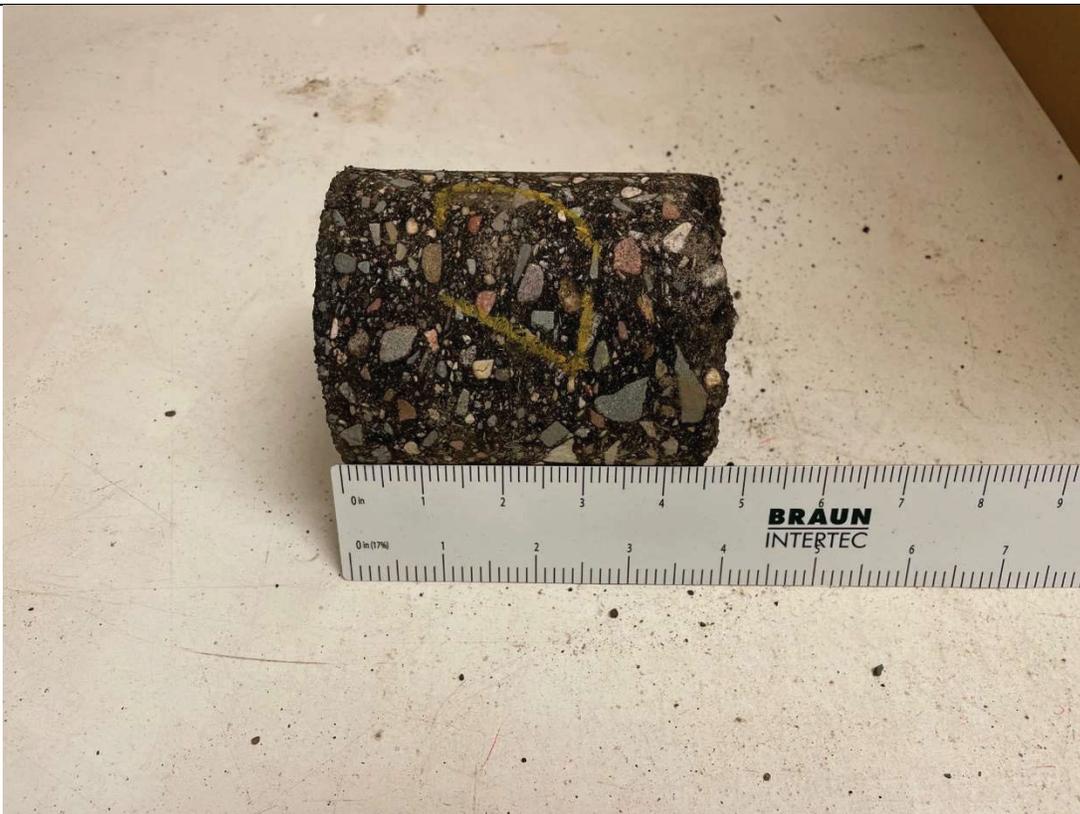
Core #:	C-7			Project: B2204011 <b>BRAUN</b> INTERTEC
Pavement thickness:	4 3/4 inches	Agg base thickness:	7 1/2 inches	
Location:	Colleen Avenue			
Date:	June 2022			
Notes:

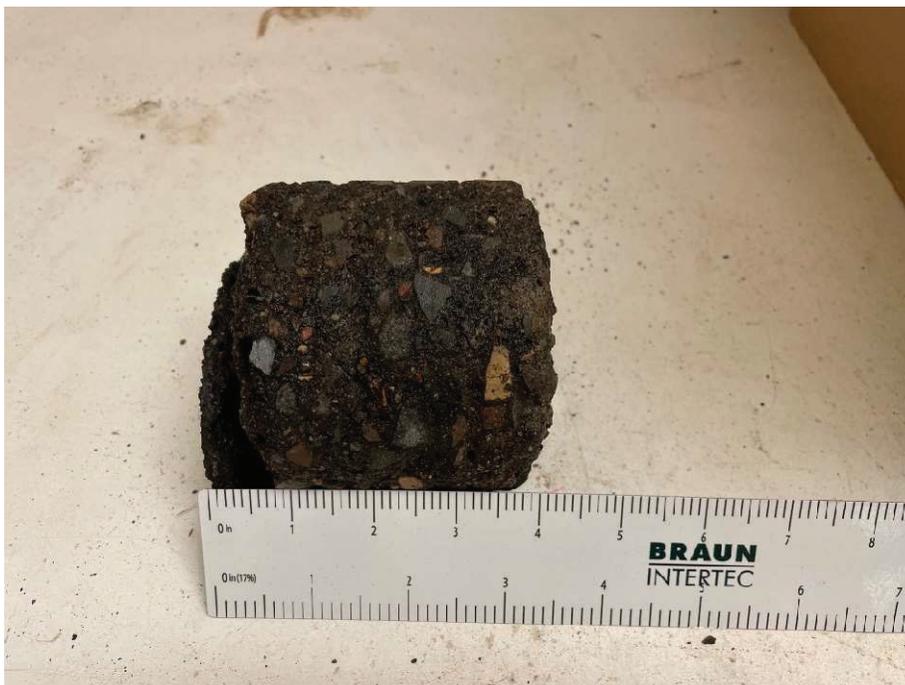
Core #:	C-8			Project: B2204011 <b>BRAUN</b> INTERTEC
Pavement thickness:	4 inches	Agg base thickness:	5 inches	
Location:	Colleen Avenue			
Date:	June 2022

Notes: Core moderately stripped throughout, chip seal debonded at surface. Actual thickness may be closer to 5".

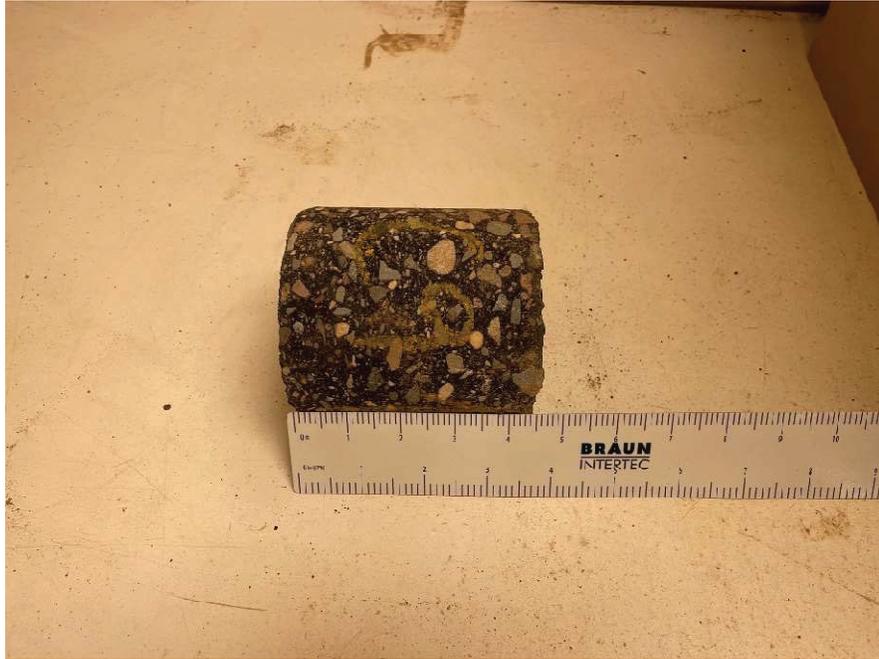
Core #:	C-9			Project: B2204011 <b>BRAUN</b> <b>INTERTEC</b>
Pavement thickness:	4 1/2 inches	Agg base thickness:	7 1/2 inches	
Location:	Colleen Circle			
Date:	June 2022

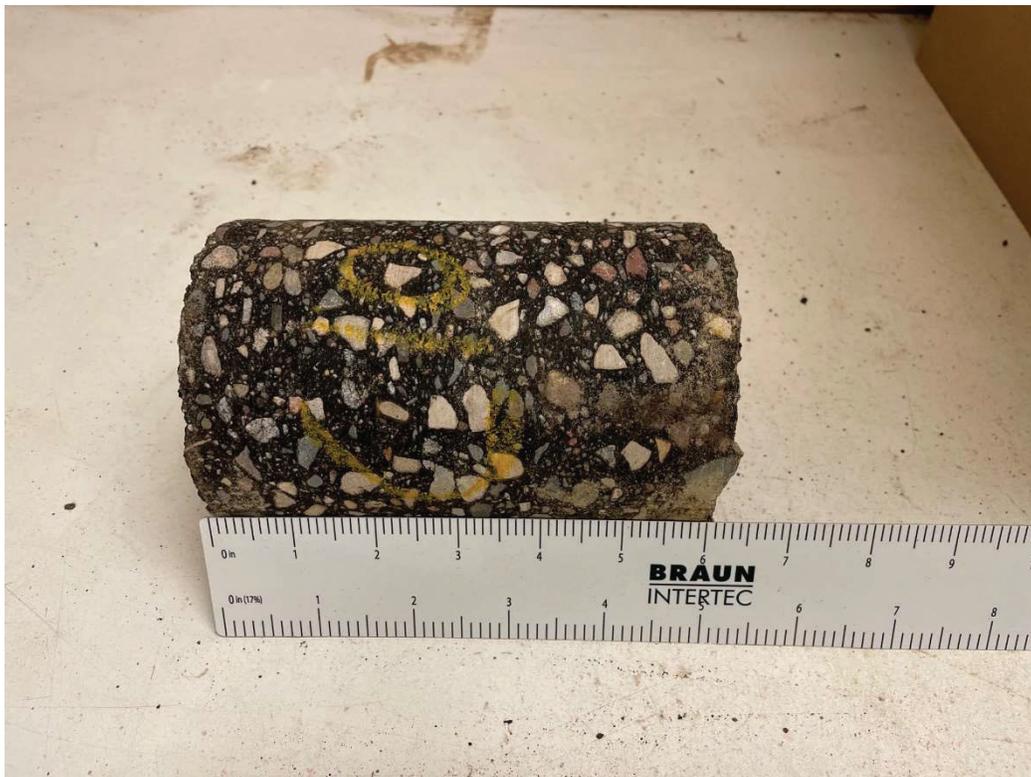
Core #:	C-10			Project: B2204011 <b>BRAUN</b> <b>INTERTEC</b>
Pavement thickness	6 1/4 inches	Agg base thickness:	3 1/2 inches	
Location:	Briarknoll Circle			
Date:	June 2022

Briarknoll Drive	C-11	4 1/4	5 1/2	Slight deterioration 1/2 inch below surface.
	C-12	3 3/4	5	Good condition.
Norma Lane	C-13	3 3/4	4	Pavement core may have disintegrated towards to the bottom during coring (possible partial recovery).
Royal Lane	C-14	5 1/2	6	Good condition.
James Avenue	C-15	3 1/2	5	Good condition.

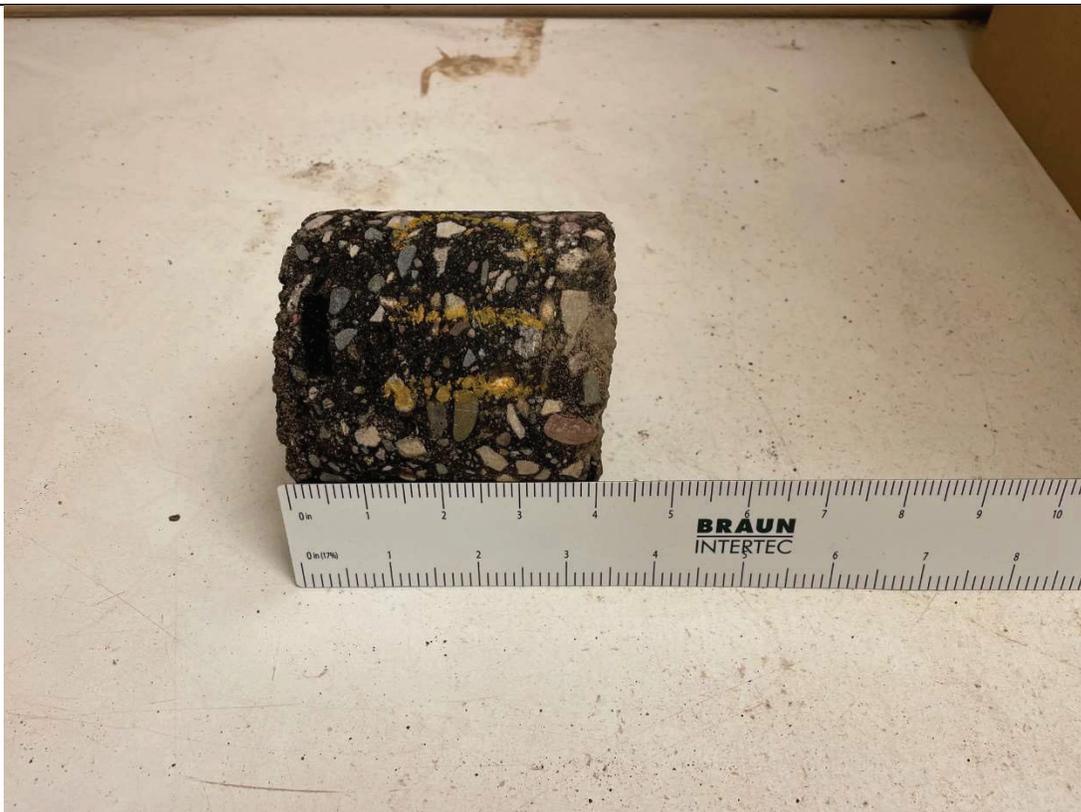
Core #:	C-11			Project: B2204011 <b>BRAUN</b> <b>INTERTEC</b>
Pavement thickness:	4 1/4 inches	Agg base thickness:	5 1/2 inches	
Location:	Briarknoll Drive			
Date:	June 2022			
Notes: Slight deterioration 1/2" down from surface.

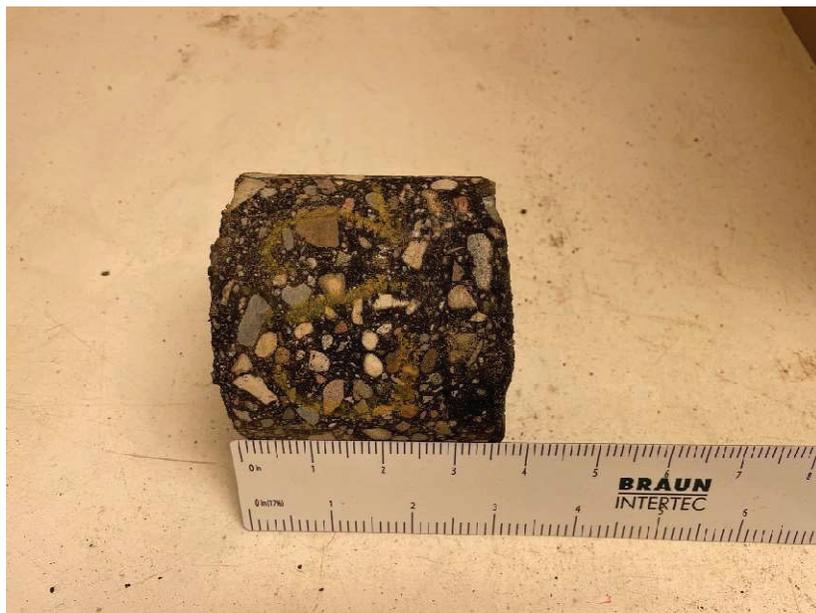
Core #:	C-12			Project: B2204011 <b>BRAUN</b> <b>INTERTEC</b>
Pavement thickness:	3 3/4 inches	Agg base thickness:	5 inches	
Location:	Briarknoll Drive			
Date:	June 2022			
Notes:

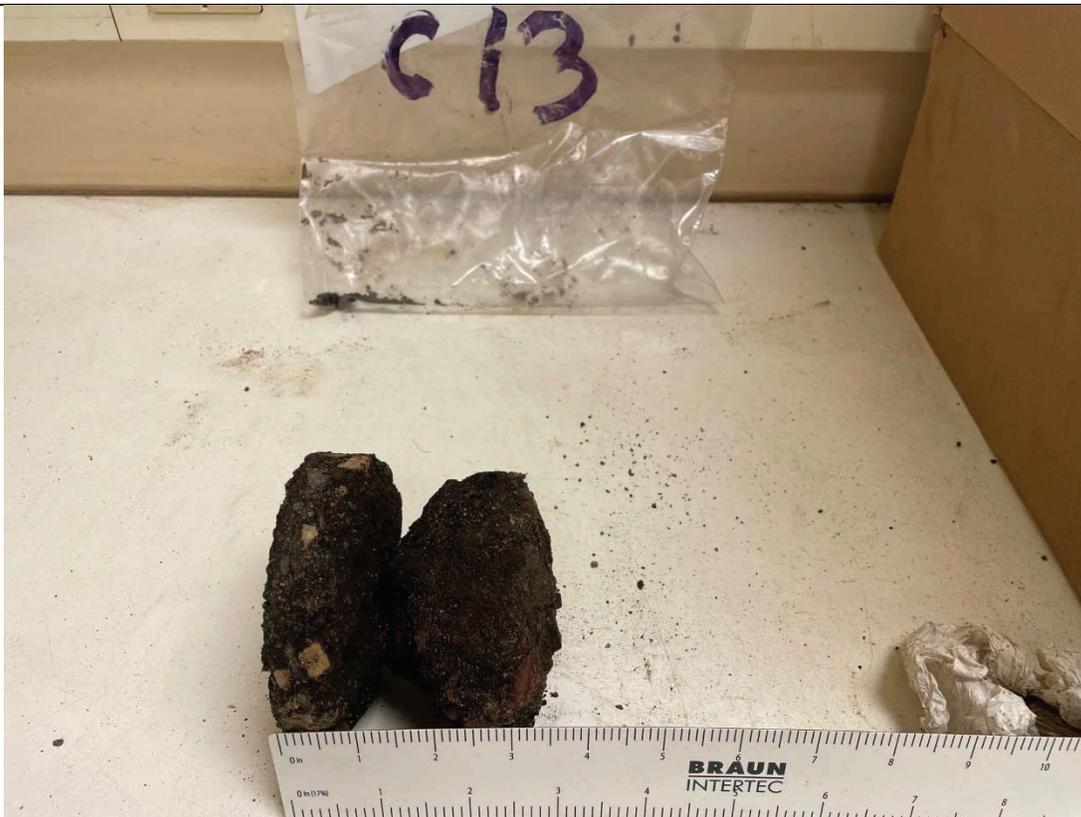
Core #:	C-13			Project: B2204011 <b>BRAUN</b> INTERTEC
Pavement thickness:	3 3/4 inches	Agg base thickness:	4 inches	
Facility:	Norma Avenue			
Date:	June 2022

Notes: Pavement disintegrated during coring. Actual thickness may be closer to 4, 4 1/2 inches.

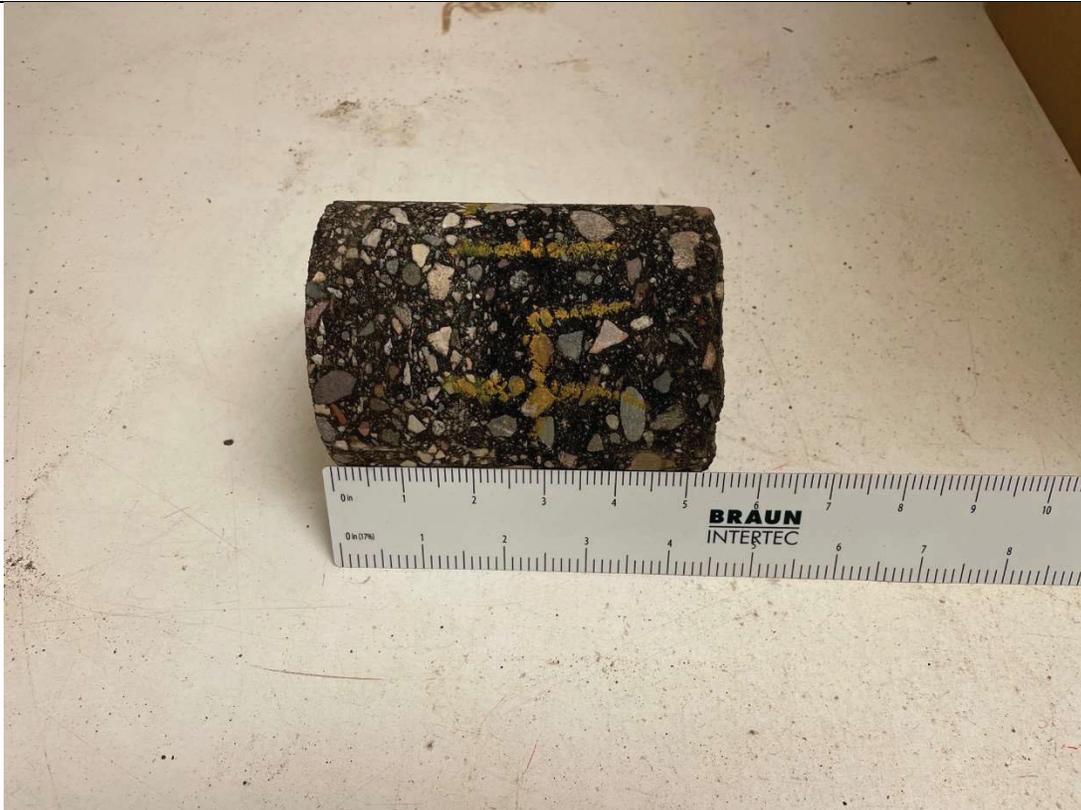
Core #:	C-14			Project: B2204011 <b>BRAUN</b> INTERTEC
Pavement thickness	5 1/2 inches	Agg base thickness:	6 inches	
Facility:	Royal Lane			
Date:	June 2022

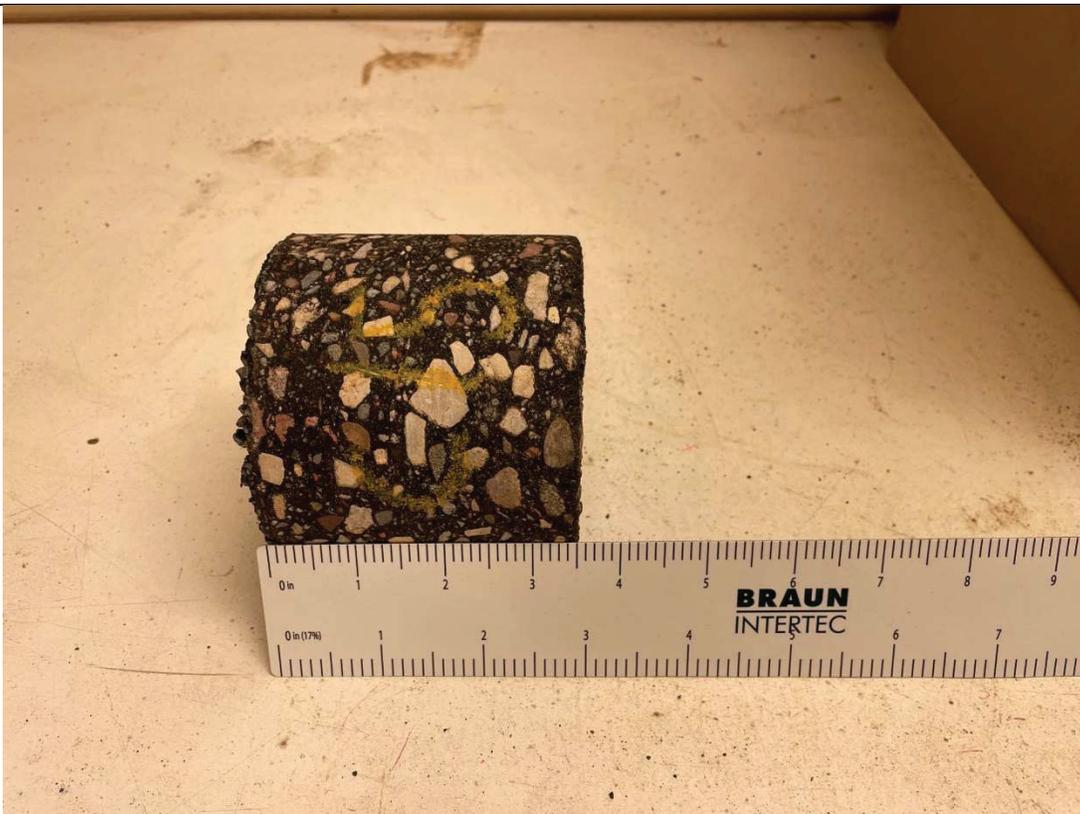
Core #:	C-15			Project: B2204011 <b>BRAUN</b> <b>INTERTEC</b>
Pavement thickness:	3 1/2 inches	Agg base thickness:	5 inches	
Facility:	James Avenue			
Date:	June 2022

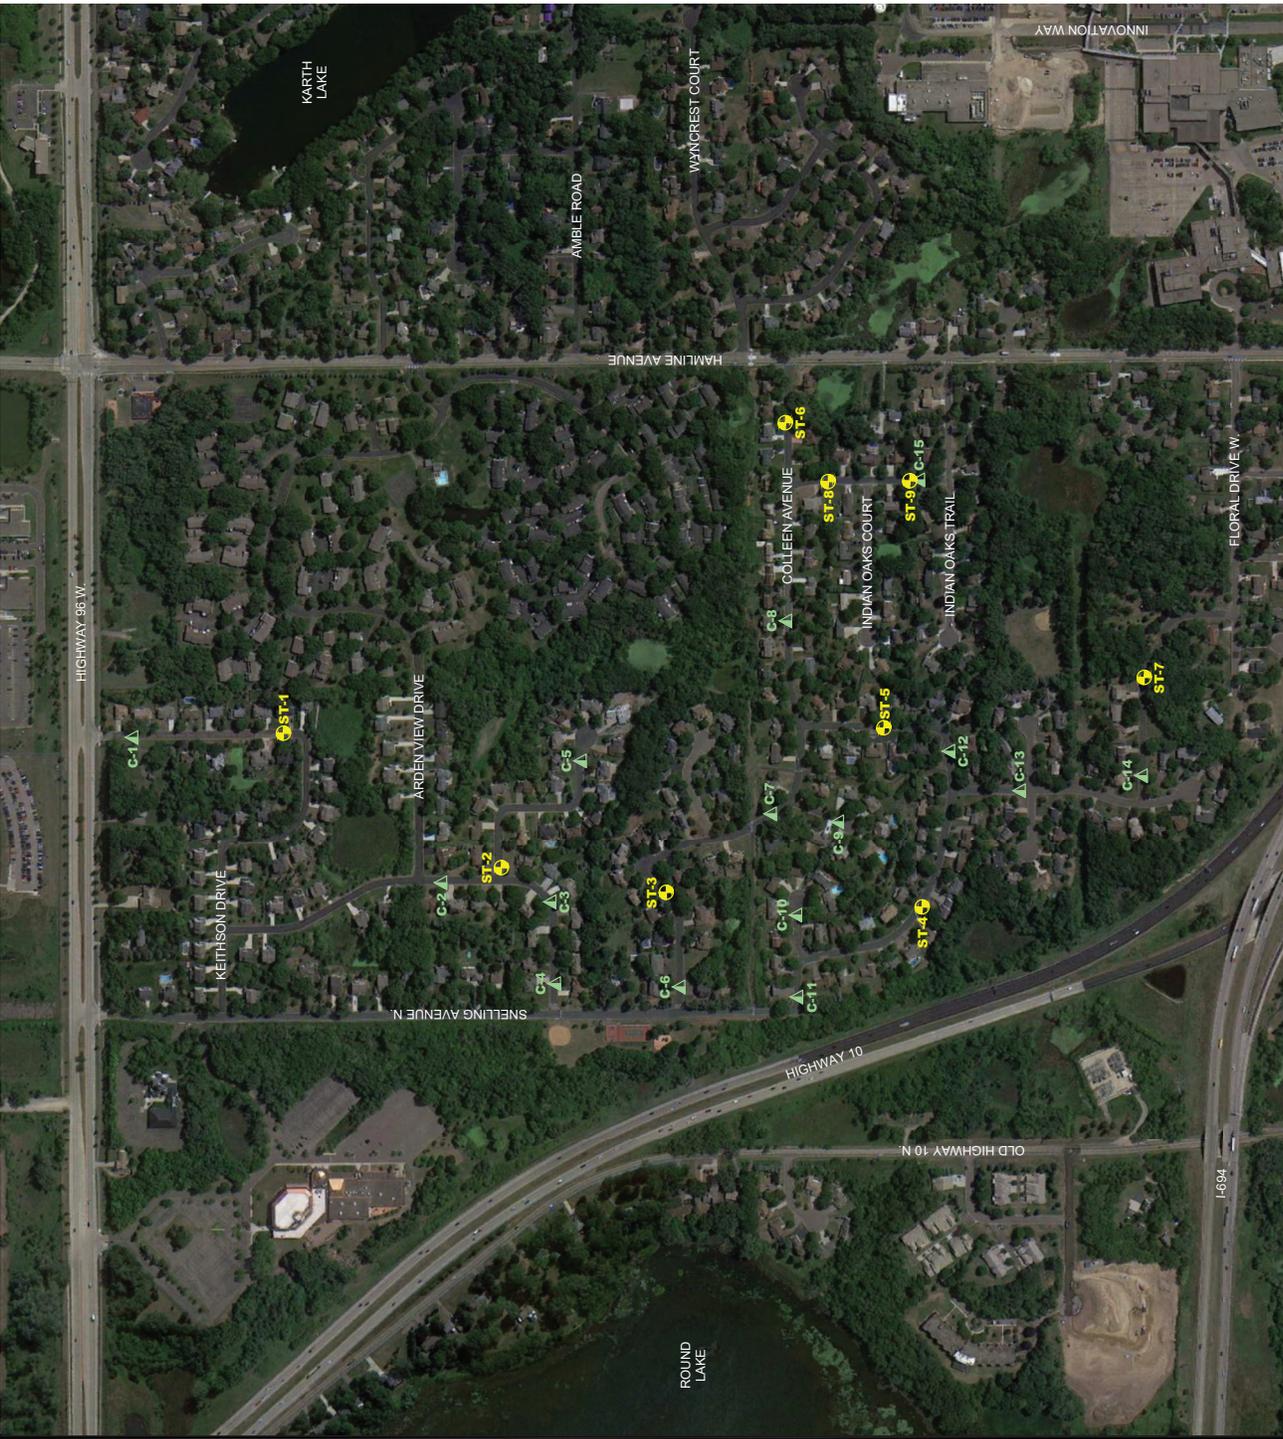
**Soil Boring  
Location Sketch**

- DENOTES APPROXIMATE LOCATION OF STANDARD PENETRATION TEST BORING
- DENOTES APPROXIMATE LOCATION OF PAVEMENT CORE

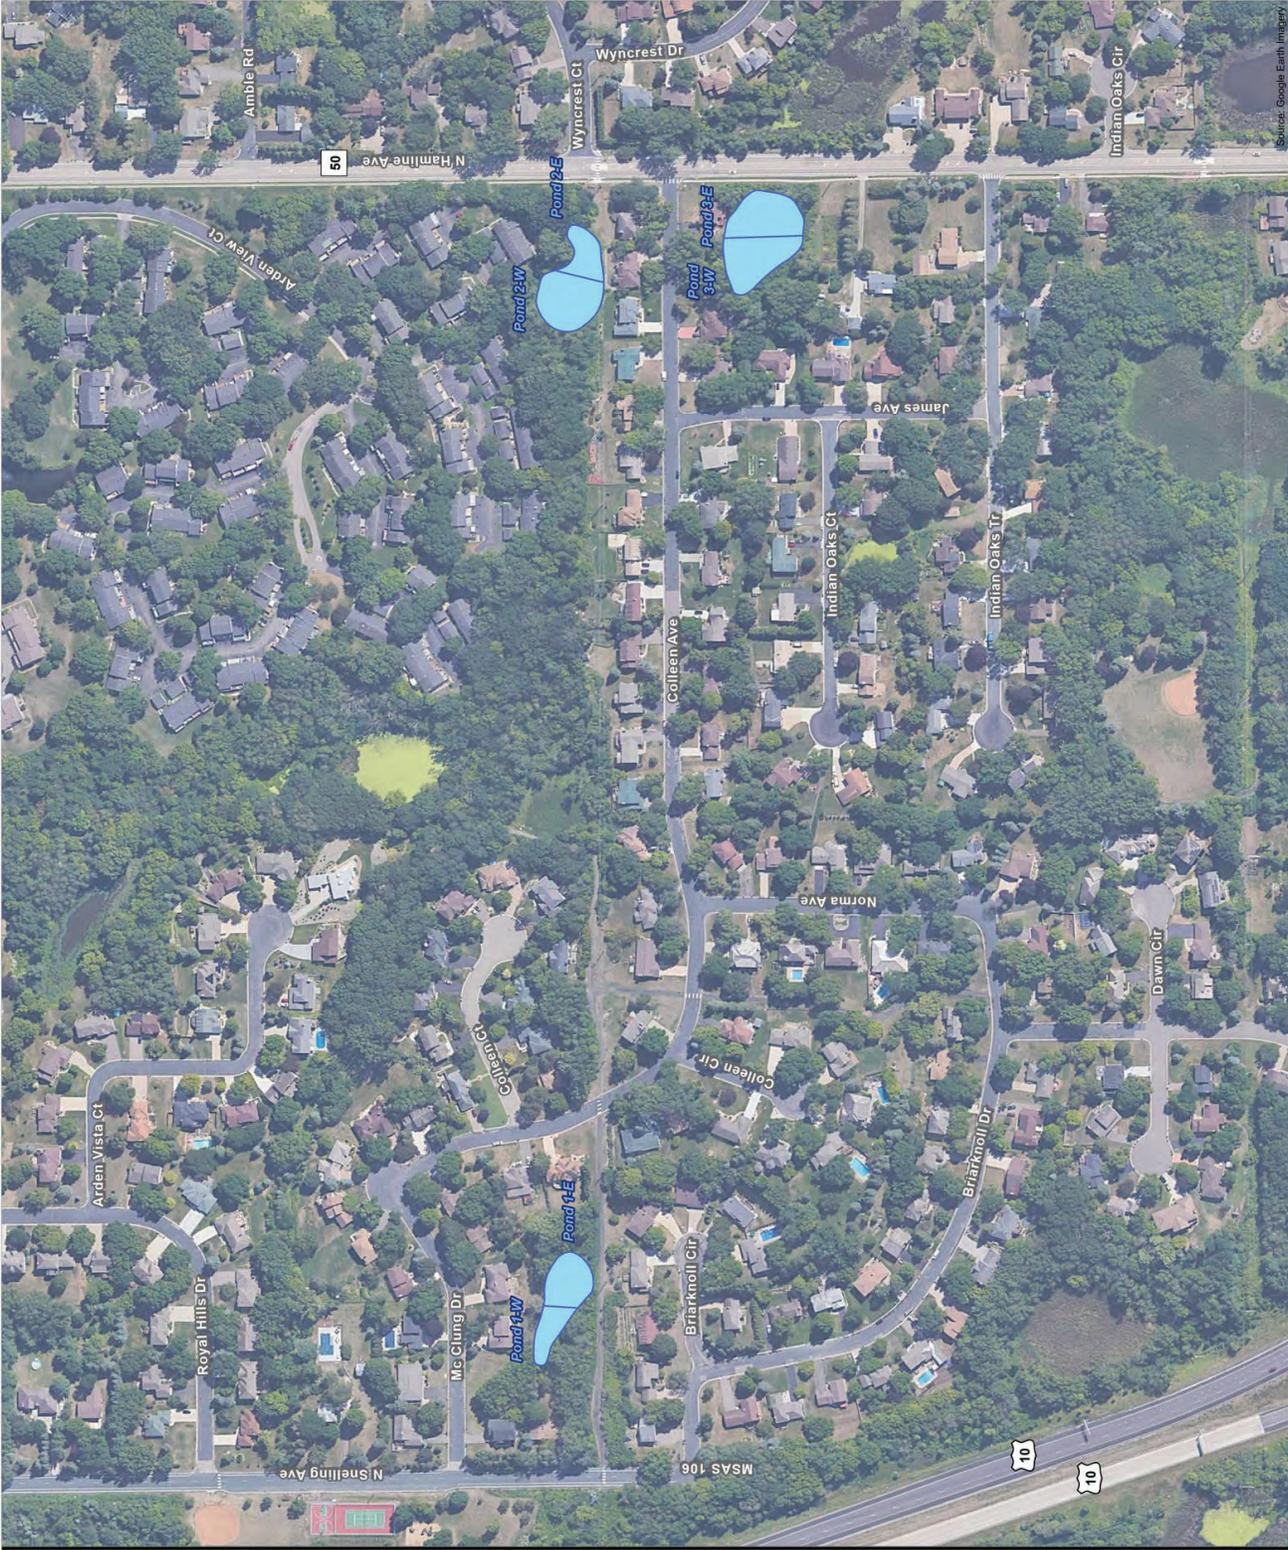
**Figure 1**  
**Sample Location Sketch**

Approximate Pond Location

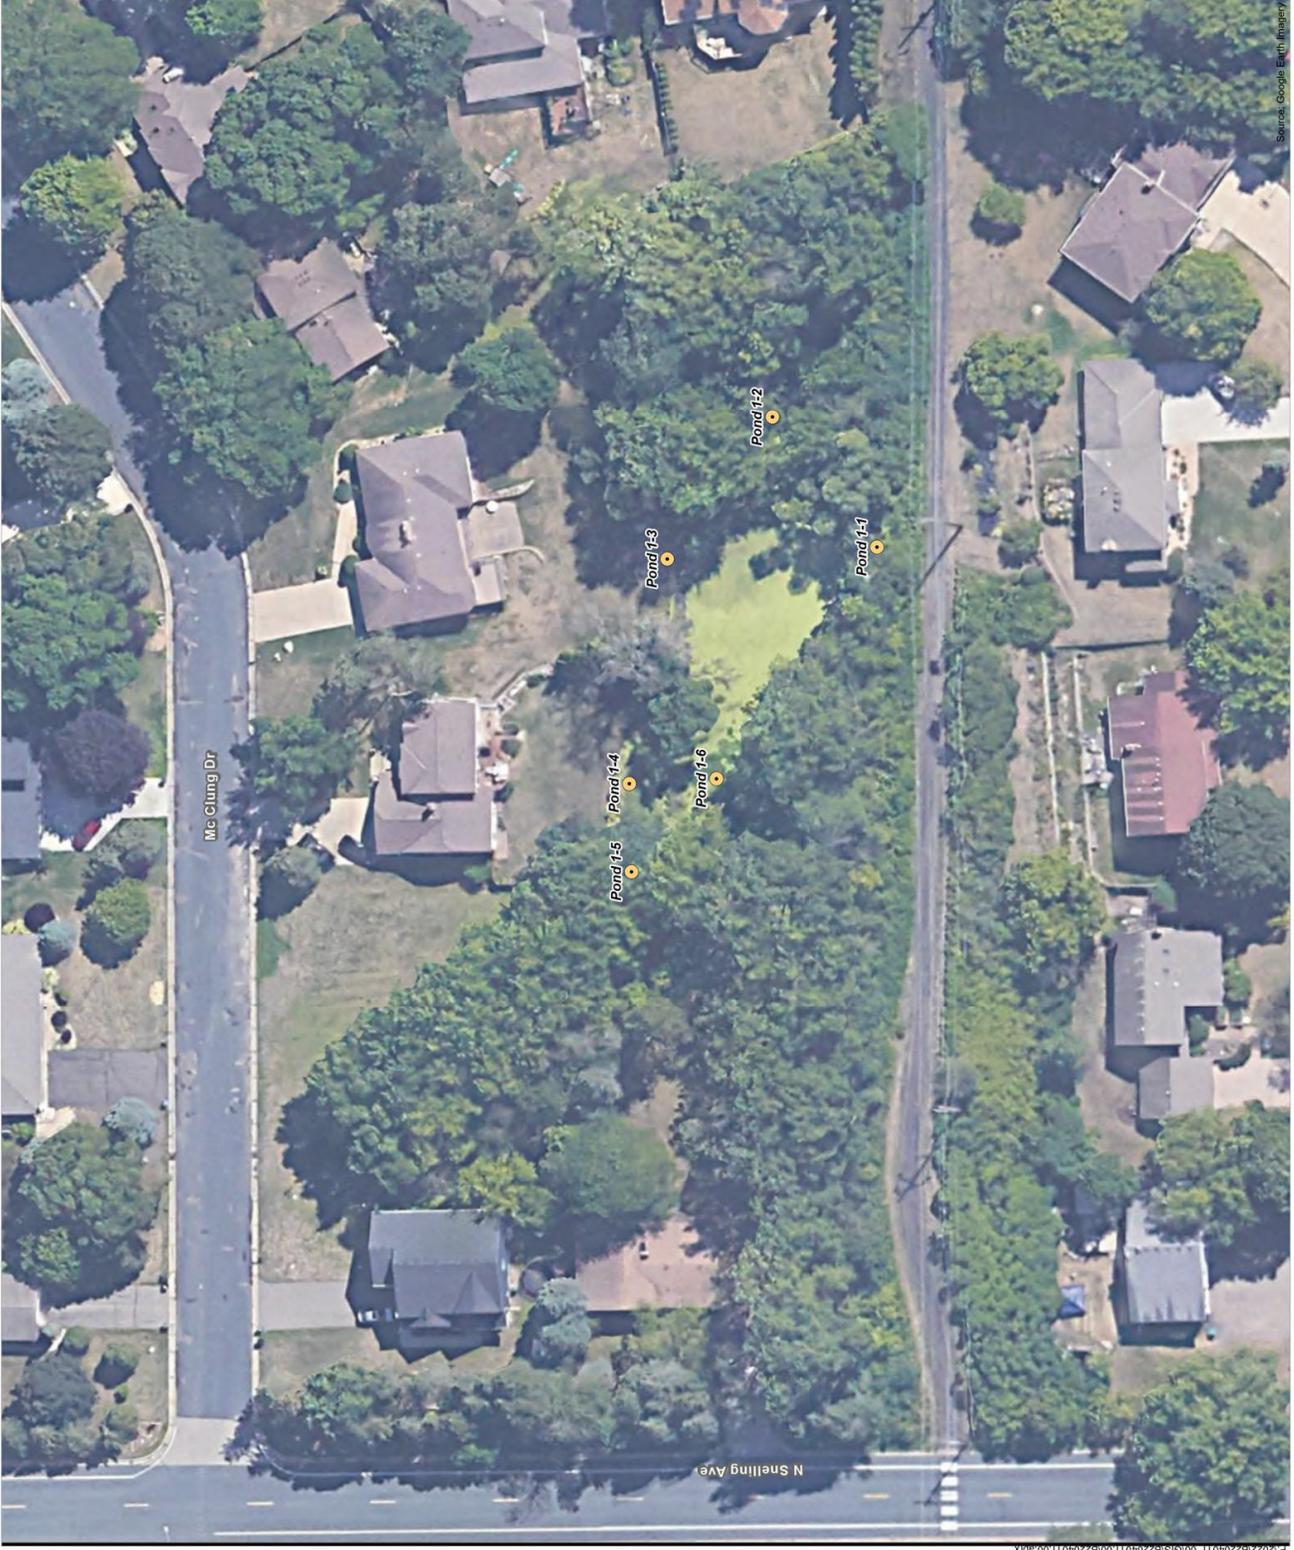
**Sample**  
**Location Sketch**

● Sediment Sample
