Feasibility Report for

# 2024 PMP Street & Utility Improvements City of Arden Hills

July 2023

City of Arden Hills  
Arden Hills, Minnesota  
City Project No. PW-24-0100  
BMI Project No. OT1.130168

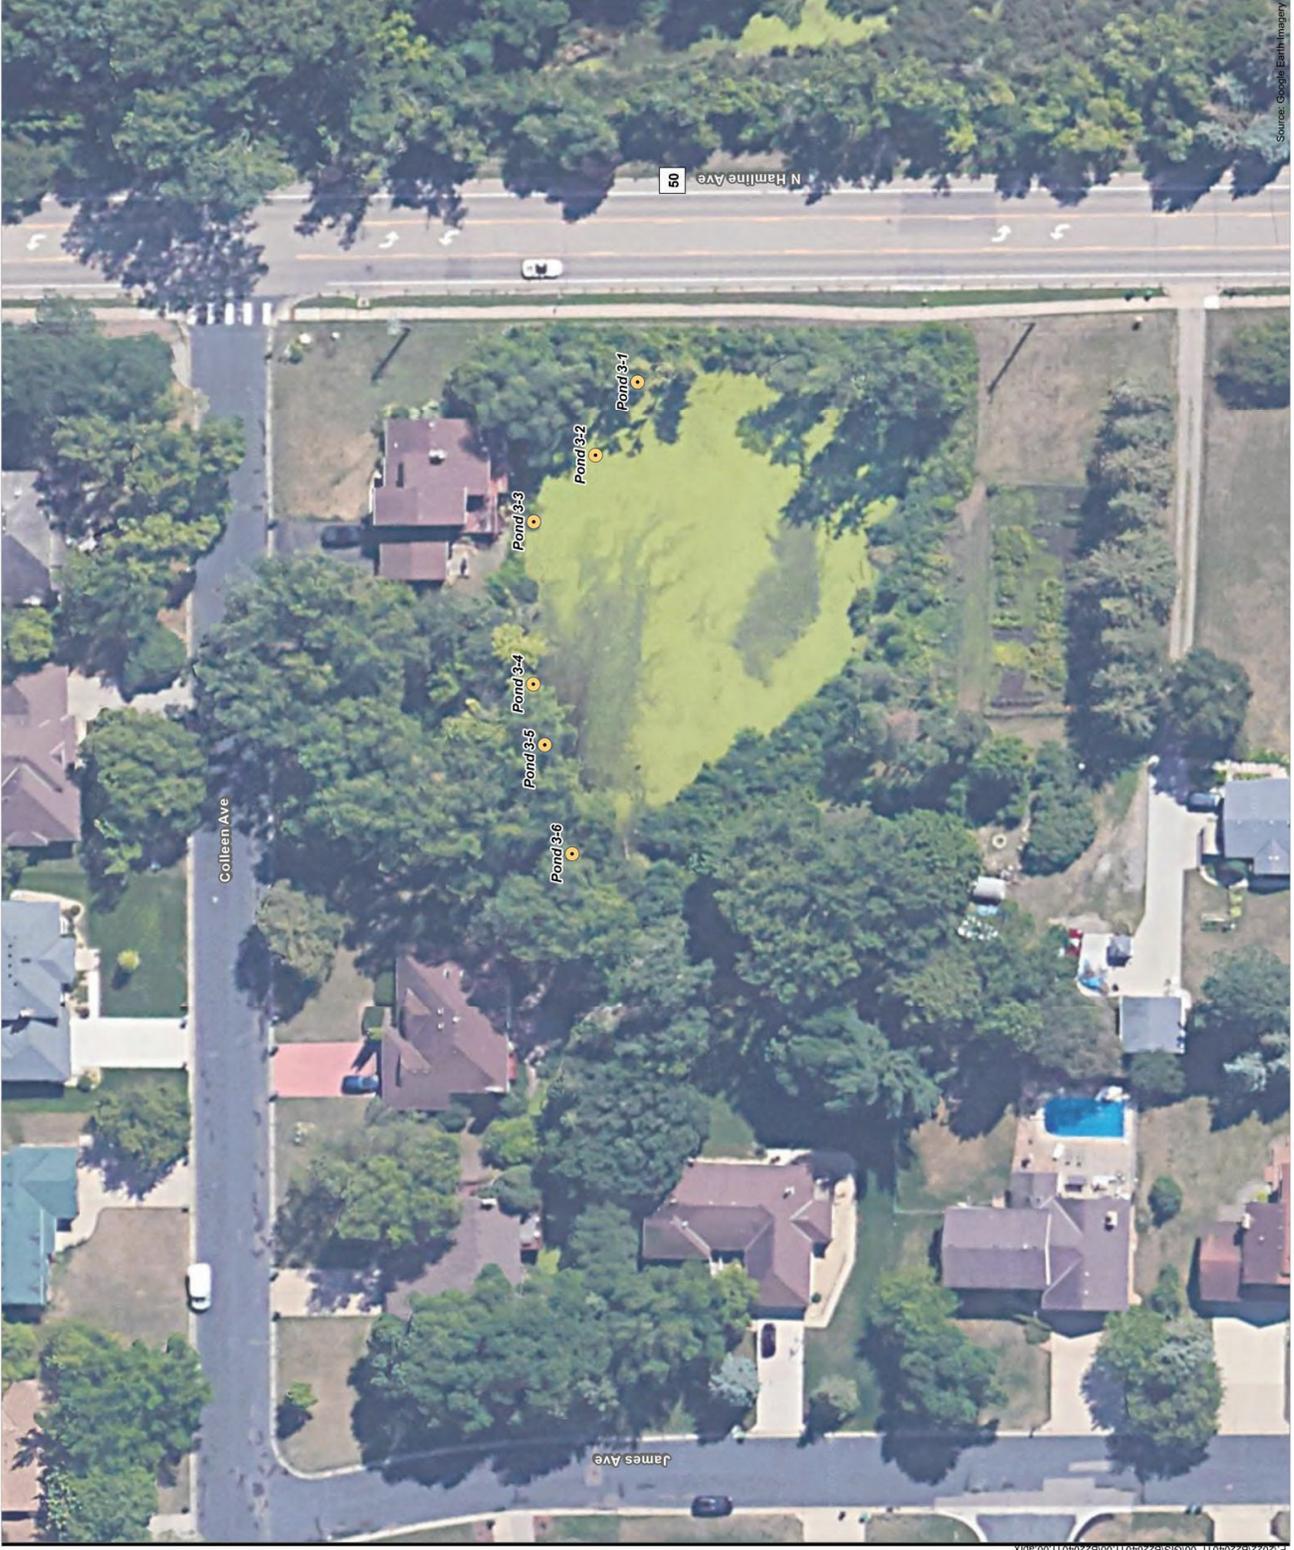
Sample Location Sketch

● Sediment Sample
